JOINT HIGHWAY RESEARCH PROJECT

JHRP-74-16

ANALYSIS OF DRIVER REACTION
TO WARNING DEVICES AT A
HIGH-ACCIDENT RURAL GRADE
CROSSING

Eugene R. Russell

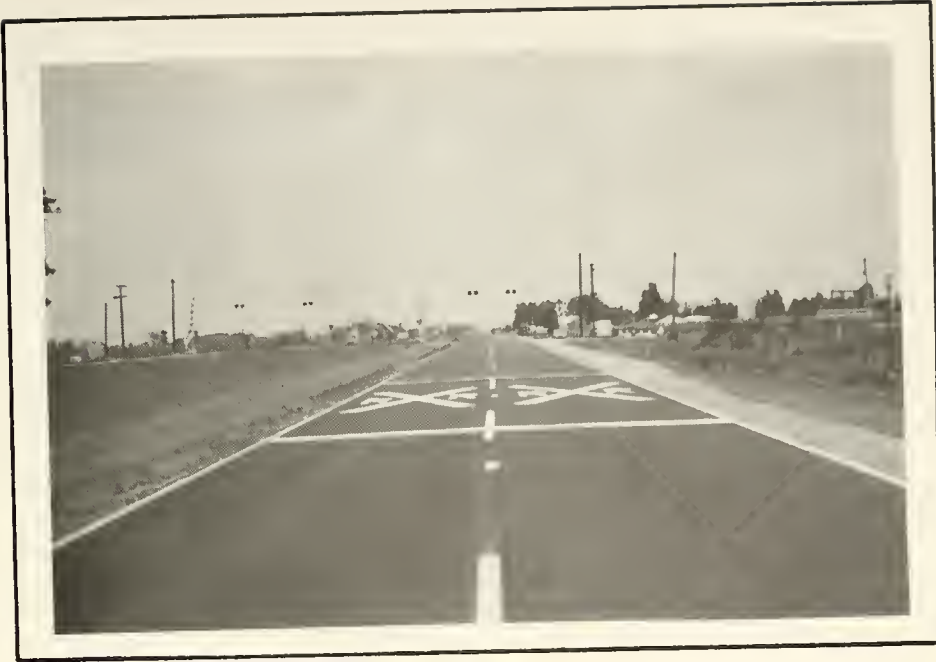
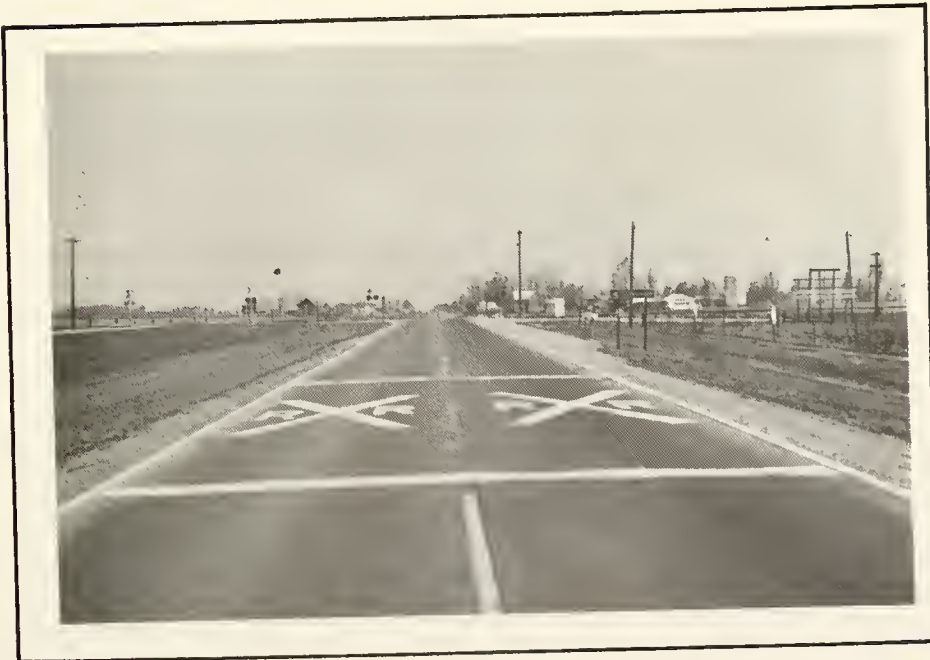
FIGURE 14. THE GOLDSMITH GRADE CROSSING AS VIEWED FROM THE NORTHBOUND LANES OF U. S. 31 BEFORE AND AFTER PROTECTION IMPROVEMENT

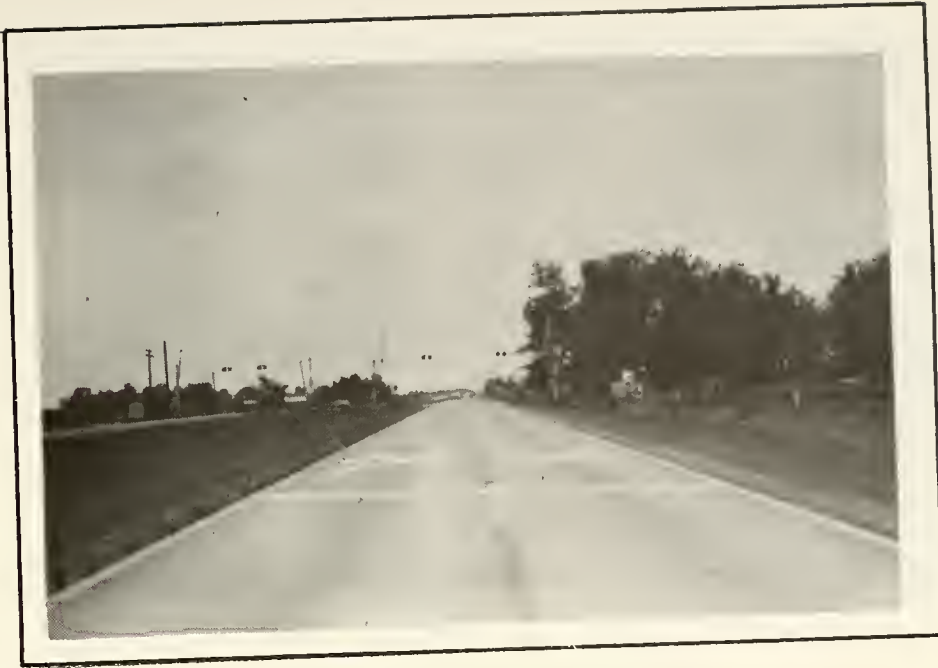
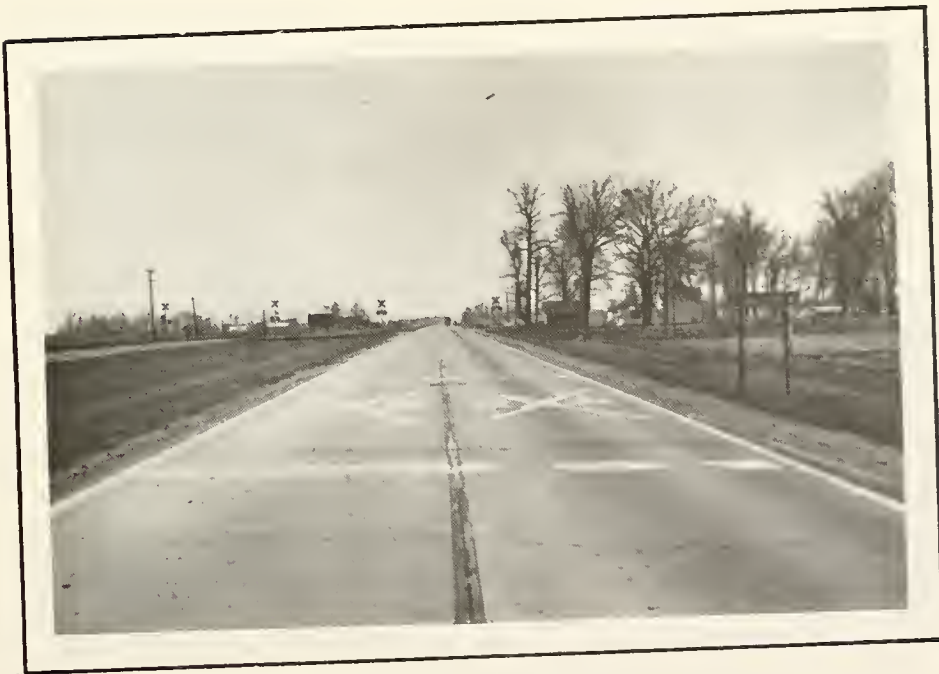
FIGURE 15. THE GOLDSMITH GRADE CROSSING AS VIEWED FROM THE SOUTHBOUND LANES OF U. S. 31 BEFORE AND AFTER PROTECTION IMPROVEMENT

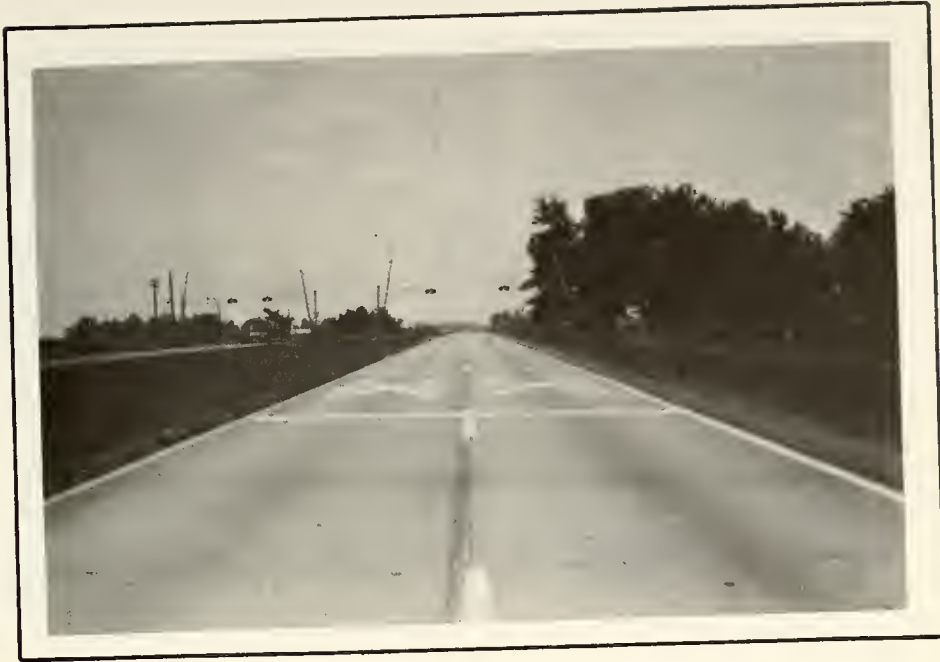
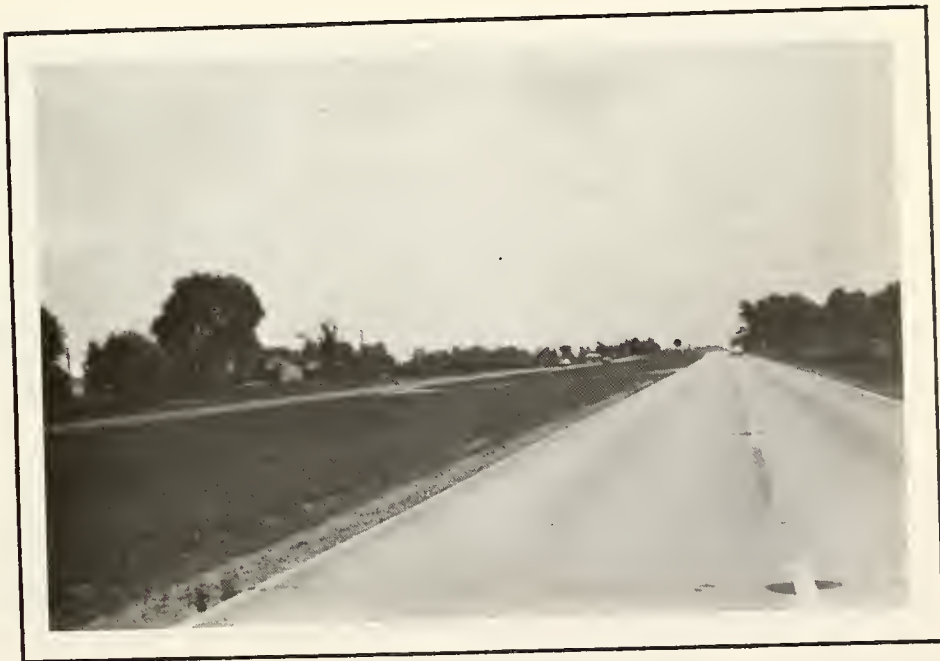
FIGURE 16. TWO VIEWS OF THE GOLDSMITH GRADE CROSSING AS VIEWED FROM THE SOUTHBOUND LANES OF U. S. 31 EMPHASIZING BACKGROUND OF TREES

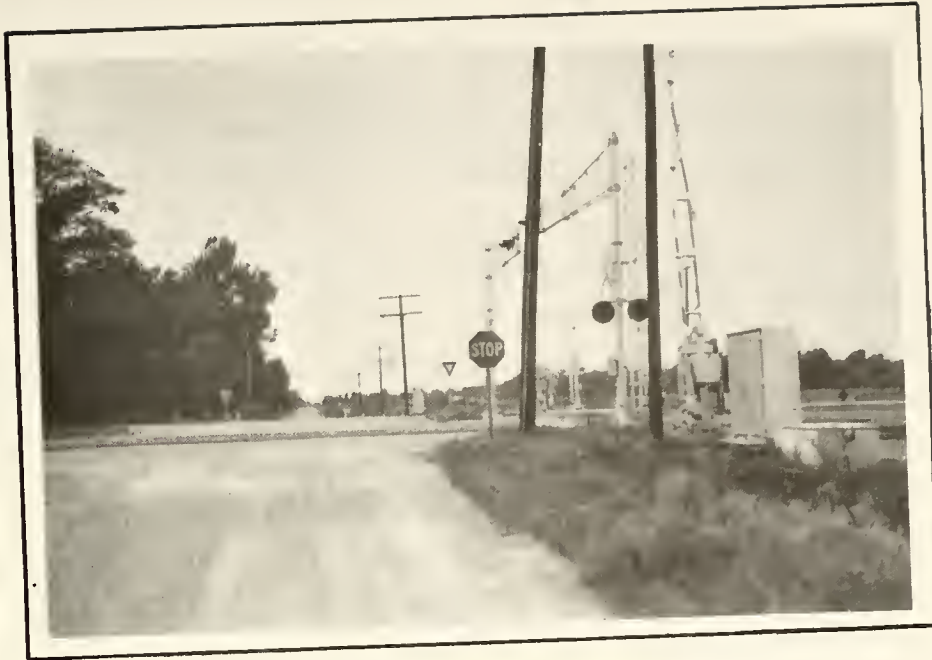
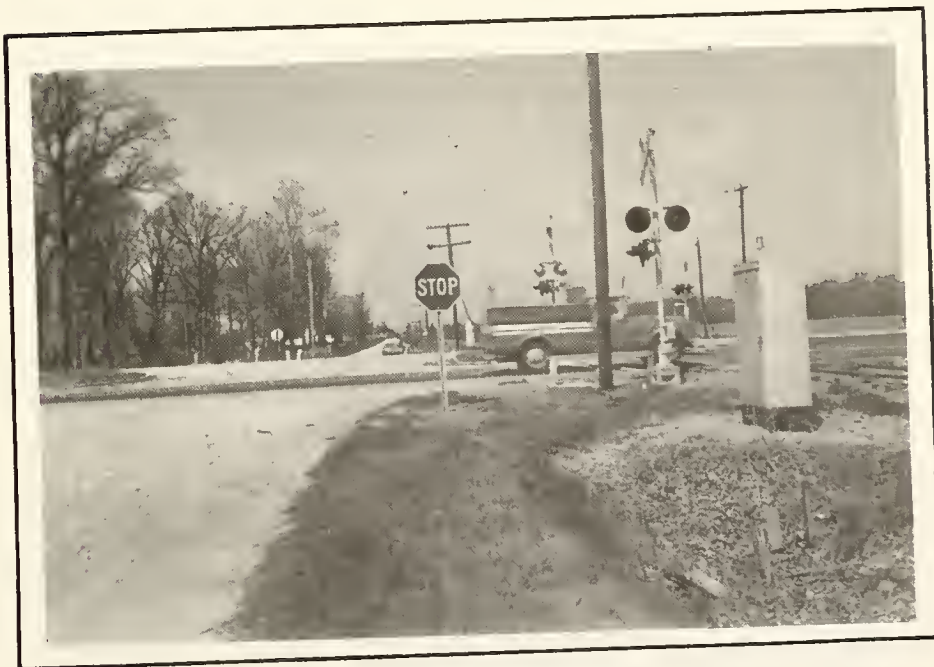
FIGURE 17. THE GOLDSMITH GRADE CROSSING AS VIEWED FROM 100S LOOKING WEST PARALLEL TO TRACKS

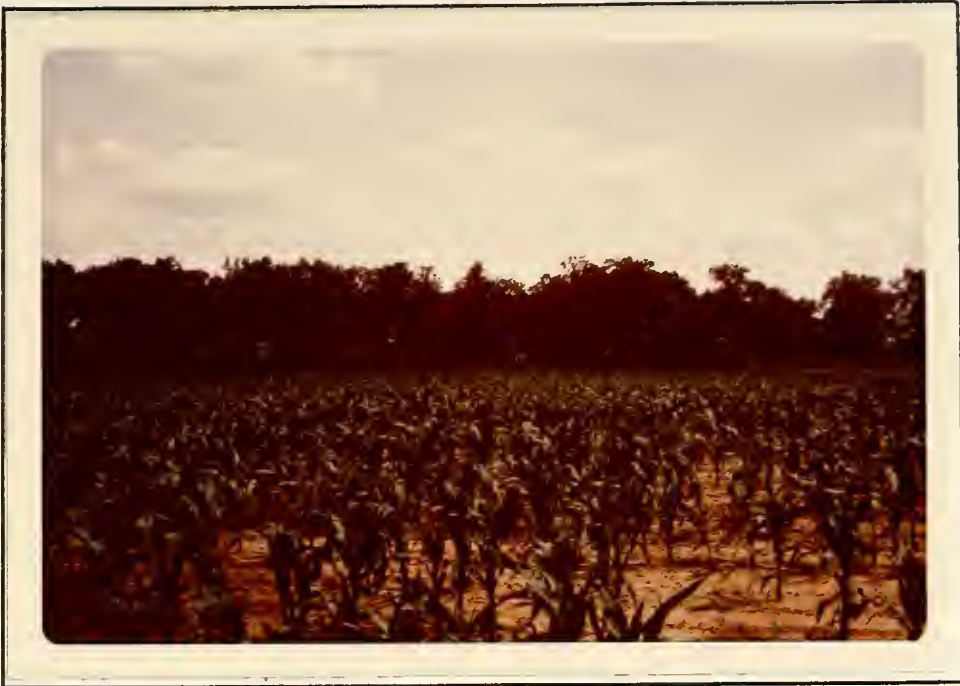
FIGURE 32. FRONT OF TRAIN AGAINST DARK BACKGROUND IMMEDIATELY WEST OF THE GOLDSMITH GRADE CROSSING

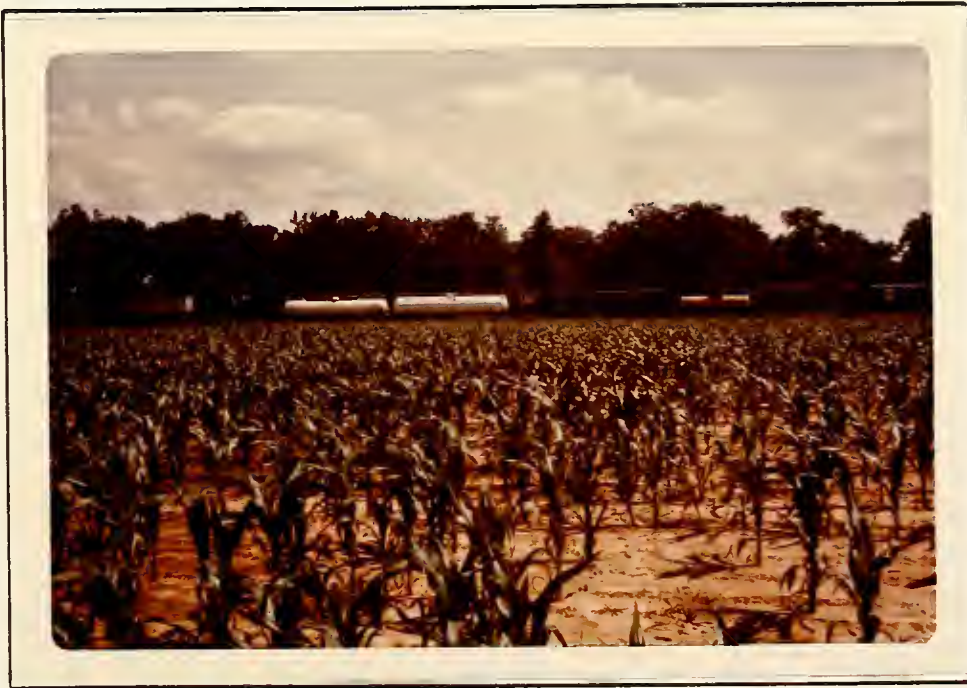
FIGURE 33. MID-SECTION OF SAME TRAIN SHOWING CONTRAST OF WHITE TANK CAR AGAINST SAME BACKGROUND

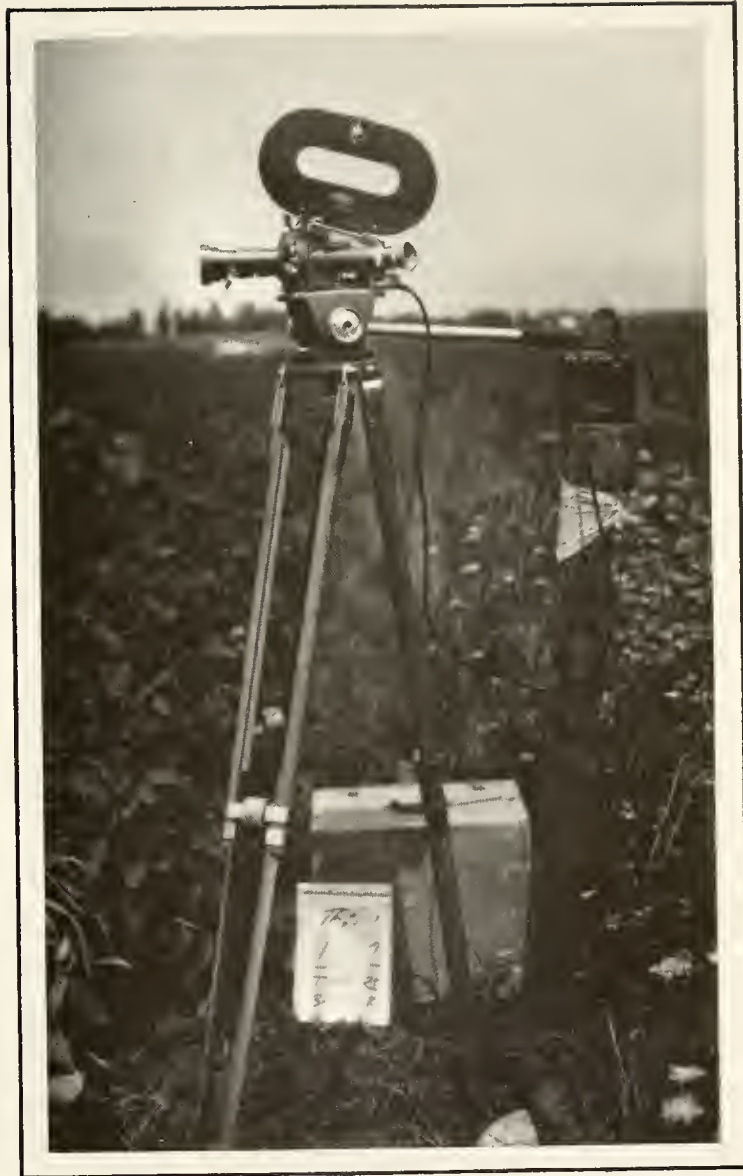
FIGURE 35. CAMERA SET-UP, READY FOR DATA COLLECTION UNDER NORMAL CONDITIONS

Since it was necessary on this project to use a 120 mm telephoto lens and "pan" with the camera to follow a car through the sequence of traps, the distance from the road could have been increased to 1000 ft. or more with no additional disadvantage. Taking advantage of this greater distance may allow a more convenient set up location, e.g., a field access road may be available. With larger markers, one could take advantage of even greater camera range. However, one must consider the possibility that large markers could possibly be too conspicuous and, therefore, have an effect on driver performance that could bias the results.

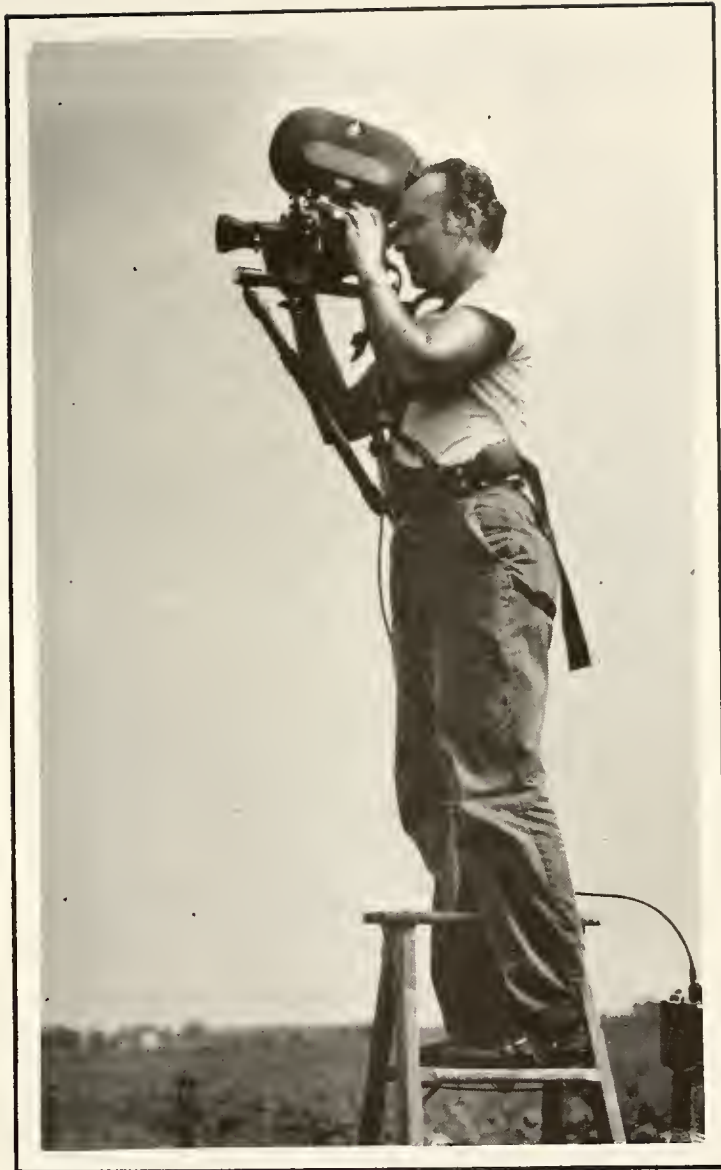
FIGURE 36. CAMERA SET-UP USED TO SIGHT OVER BEANS
THAT OBSCURED THE LINE-OF-SIGHT LATE
IN THE SUMMER
